# NATIONAL TRANSPORTATION SAFETY BOARD

## MATERIALS LABORATORY FACTUAL REPORT

Report No. 03-054

Place : Everglade City, Florida.  
Date : December 30, 2002  
Vehicle : Tour boat "Panther".  
NTSB No. : DCA03MM018  
Investigator : Robert Ford

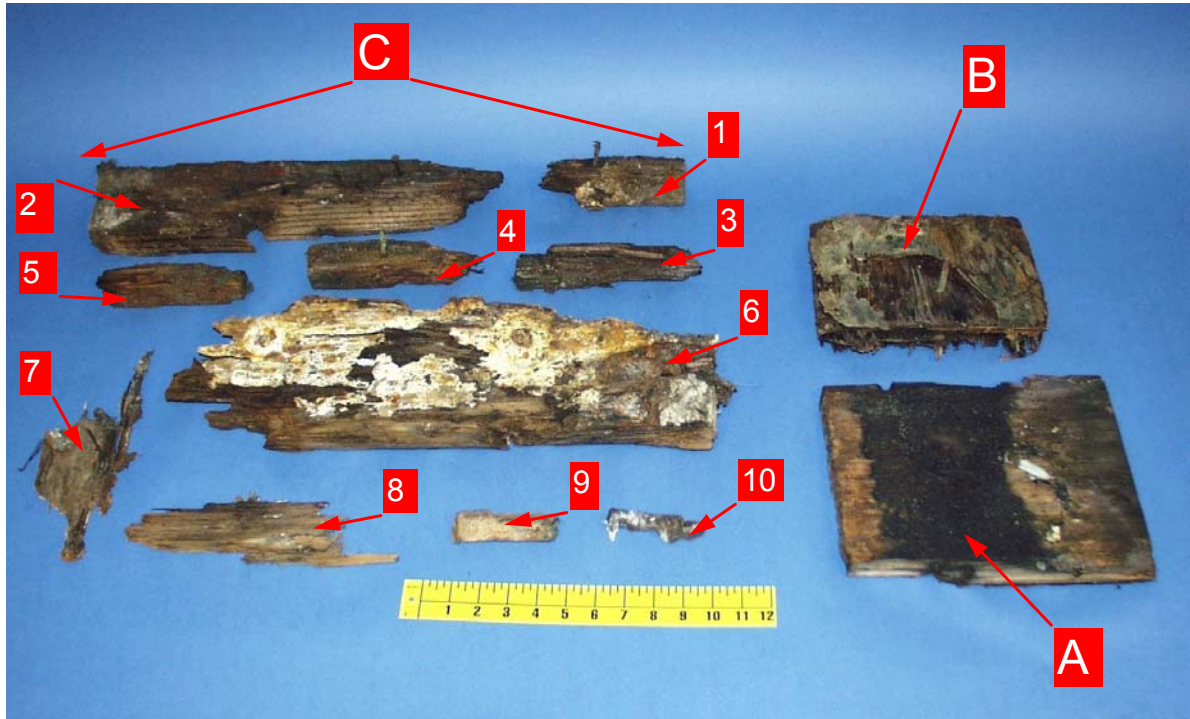
Portions of the vessel's strut block pieces were received for examination and are illustrated in figure 1. The portions are identified as blocks "A", "B" and "C". Preliminary examination revealed that block "A" consisted of a single piece of wood approximately 11" x 8" x 1" thick. Block "B" consisted of a piece of plywood approximately 9" x 7" x  $\frac{7}{8}$ " thick. Block "C" consisted of the 10 variously shaped pieces individually numbered as in figure 1.

Figure 1. Pieces of the wooden strut blocks received for examination.

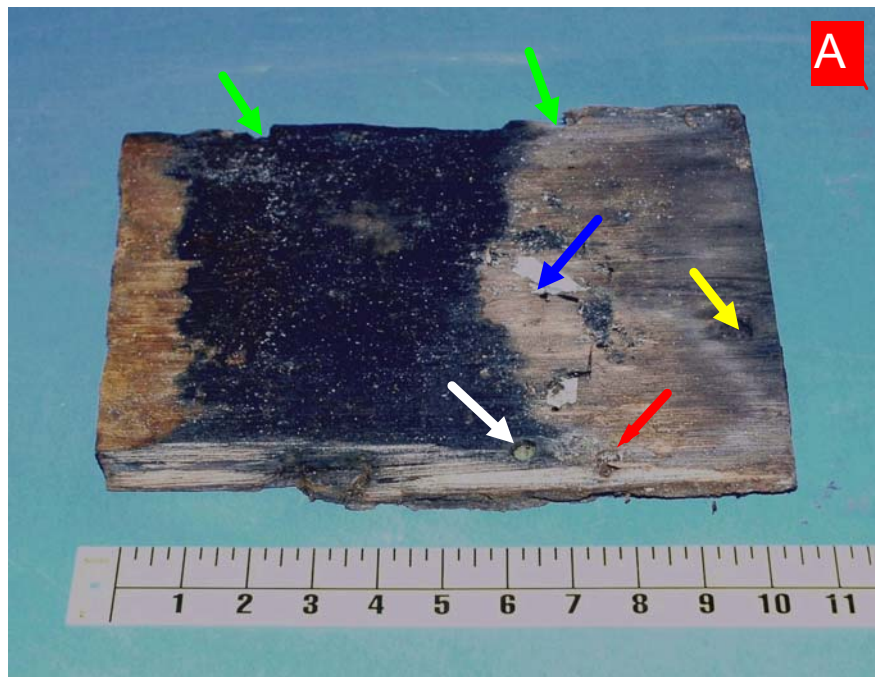
Examination of block "A" revealed that it was a single piece of wood that was resistant to penetration by a fingernail and had an odor as if it had been treated with creosote. One fractured edge displayed two partial through holes and there were two small holes through the thickness. There was a third through thickness hole that was filled with a hard translucent green plastic material. A knot on one surface was pried loose with a fingernail to reveal that the underlying material was a matt black color. One surface of

block "A" is illustrated in figure 3 with the green arrows indicating the partial holes and the red and blue arrows indicating the through holes. The white arrow indicates the hole filled with the green material and the yellow arrow indicates the location of the knot.

Blocks "A", "B", "C2" and "C6" were shipped to the USDA Forest Products Laboratory for identification of the wood and determination of the type of decay observed. Block "A" was identified as bald cypress, which is quite resistant to decay. The softer material at the edges was determined to be either brown rot or soft rot fungi and the odor was consistent with a creosote treatment. The decay on block "B" was determined to be brown rot fungi, which was so intense that identification of the woods utilized in the plywood was not possible. Blocks "C2" and "C6" were determined to be southern yellow pine and the decay was brown rot fungi. Numerous cross grain cracks appeared when a sharp instrument was

Figure 3. One surface of the strut block identified as "A" in figure 1.

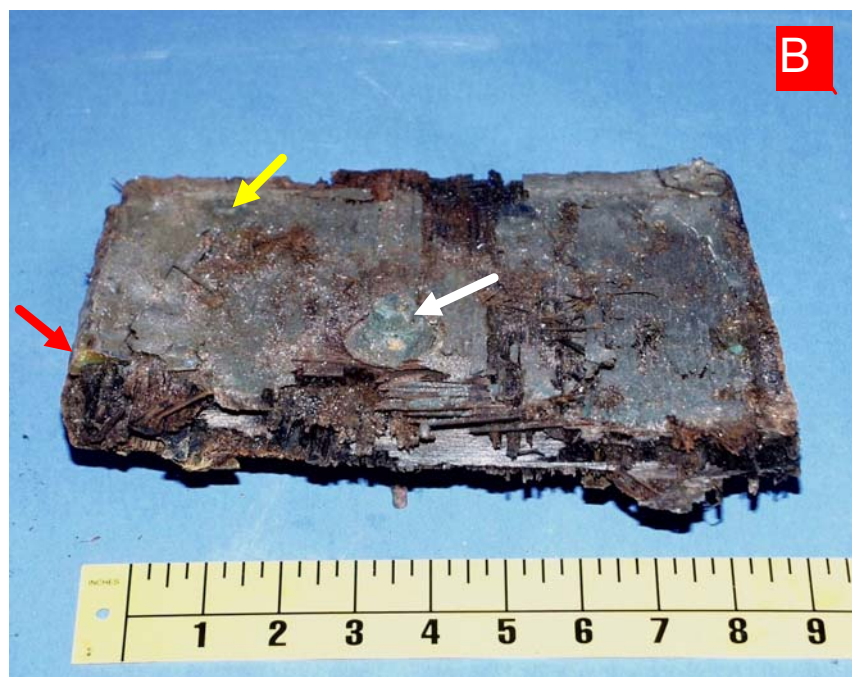
Block "B" was a piece of plywood that was falling apart especially at the edges and displayed a brown coloration on exposed surfaces. A fingernail pressed on to a surface would leave an indentation. The examination revealed a hard translucent tan material along one edge and two hexagonal shapes that protruded from one surface. This surface is illustrated in figure 4 with the red arrow indicating the end of the tan material and the white and yellow arrows indicate the hexagonal shapes. The discoloration and deterioration of one edge of this block is evident in figure 4.

Figure 4. One surface of the strut block identified as "B" in figure 1.

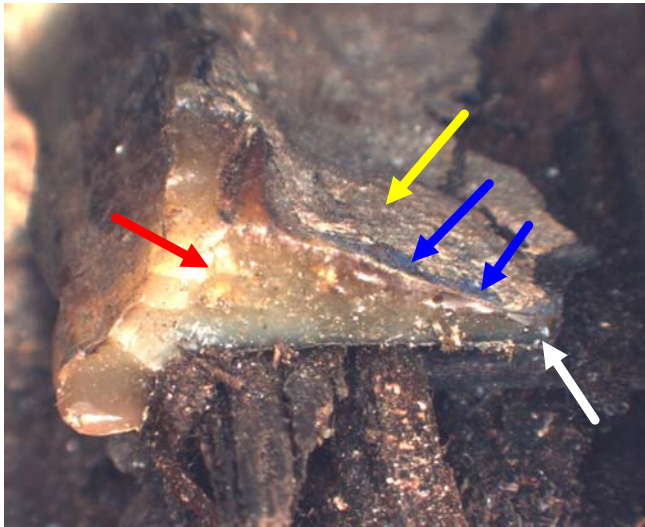
The end of the translucent tan material, indicated by the red arrow in figure 4, is similarly indicated in figure 5. As illustrated, the translucent material was "T" shaped and was located on the upper surface of the block and partially down the edge. The thickness of the portion on the surface reduced as its distance from the edge increased, and the portion on the edge displayed a rounded tip. Elevation of a thin portion on the surface revealed that the material was brittle. The blue arrows indicate a blue coating on the tan material and the yellow arrow indicates a rough textured tan coating on top of the blue coating. The discoloration and deterioration of the plywood is evident on the illustrated edge in the foreground of figure 5.

Figure 5. The feature indicated by the red arrow in figure 4.

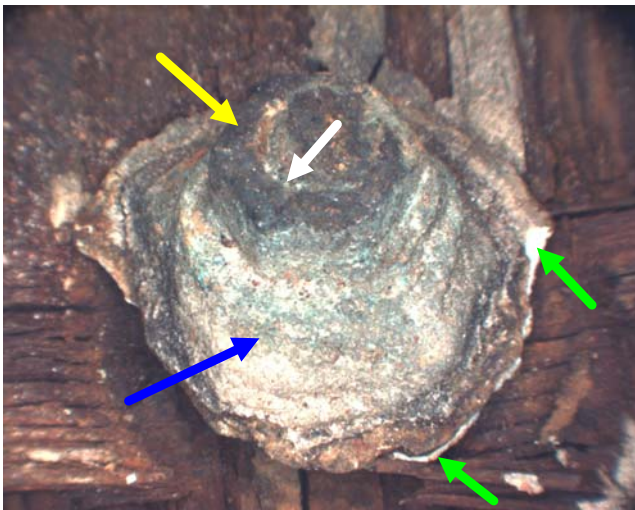
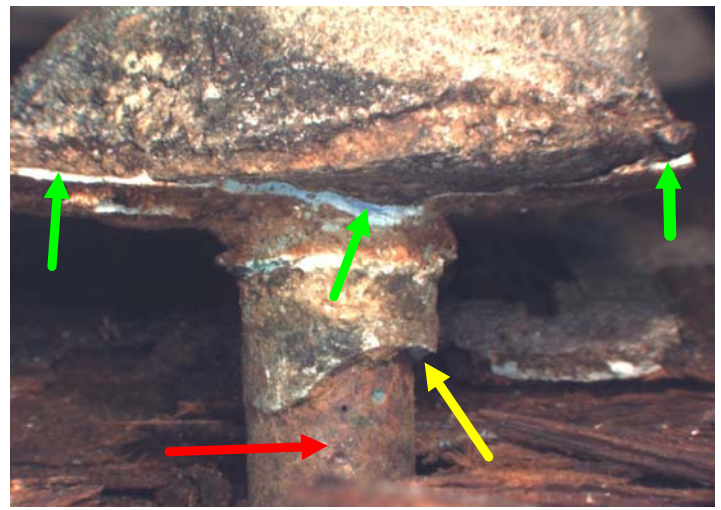
Examination of the hexagonal shape indicated by the white arrow in figure 4 revealed that it was a nut on top of a 1/2-inch thickness of washers. The number of washers could not be determined due to the amount of hard encasing material. At the interface with the plywood surface there was a thin white layer. The encased nut and washer assembly was elevated to reveal that the white layer covered the underside of the lowest washer and the diameter of the bolt the nut was attached to. The left view of figure 6 illustrates the hexagonal shape indicated by the white arrow in figure 4. The yellow arrow indicates the nut and the blue arrow indicates the washers. The white arrow indicates a circular depression suggestive of the interface between the bolt thread and the nut. The green arrows indicate the white layer. The right view of figure 6 illustrates the underside of the lowest washer and the bolt shank. The green arrows, as in the left view, indicate the white layer, the red arrow indicates the corroded bolt shank and the yellow arrow indicates more of the white material around the bolt shank.

Figure 6. The feature indicated by the white arrow in figure 4 (left view) and the underside of the same feature (right view).

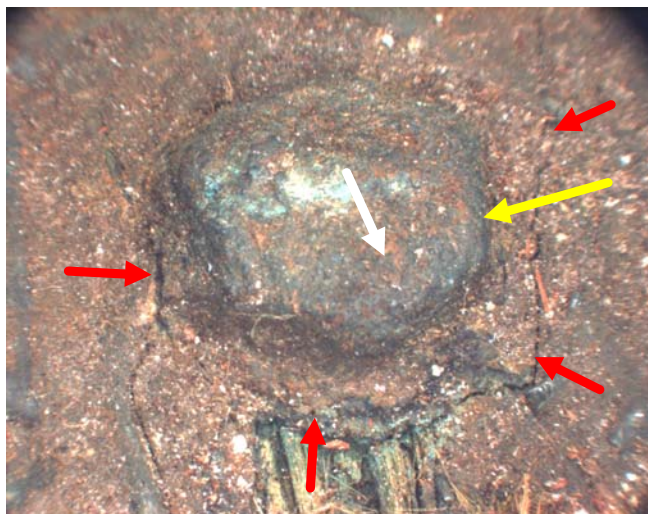
The hexagonal shape indicated by the yellow arrow in figure 4 is illustrated in figure 7. The yellow arrow indicates the misshaped edges of the nut, and the white arrow indicates a circular depression suggestive of the interface between the bolt thread and the nut. The red arrows indicate a crack in the material that coated the nut and the adjacent plywood surface, which had propagated around the nut.

Figure 7. The feature indicated by the yellow arrow in figure 4.

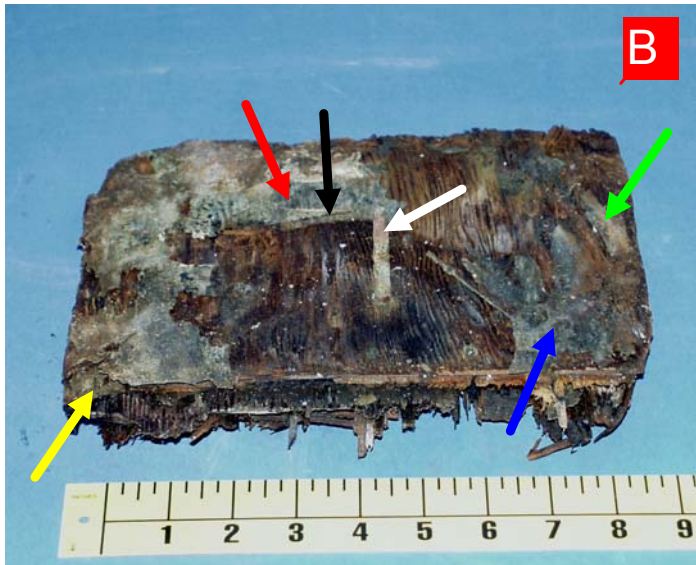
Examination of the other side of block "B", see figure 8, revealed more deterioration to the plywood. The white arrow in figure 8 indicates the protruding remains of a bolt shank that was attached to the nut indicated by the white arrow in figure 4. Also, the green arrow in figure 8 indicates where the broken shank of the bolt that was attached to the nut

indicated by the yellow arrow in figure 4 was located just below the block surface. Some of the plywood surface was covered with what appeared to be a blue/gray translucent material with an average thickness of  $\frac{1}{16}$ -inch. Examination revealed that some of this material was dark brown on the inside and some was a tan color. A uniform  $\frac{1}{16}$ -inch layer of a dark tan material was exposed between the plies at one corner. The red and blue arrows in figure 8 indicate areas where the inside of the surface covering was dark brown and the black arrow indicates where the inside was tan colored. Both the dark brown and the tan colored materials were hard and broke easily when bent.

Figure 8. The other side of strut block "B" illustrated in figure 4.

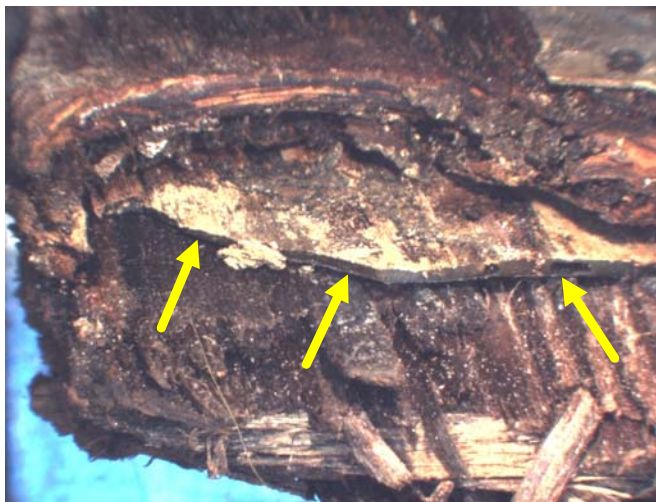
A layer of what appeared to be hard, dark tan plastic was found approximately in the center of the plies of the plywood. This plastic layer is indicated by the yellow arrow in figure 8 is similarly indicated in figure 9. As illustrated in figure 9, there were three wood plies located above the dark tan material and four plies located below it. The material was of uniform thickness and appeared to continue into the block and along the fractured edge illustrated in figure 8. The deterioration of the plywood is evident in the illustrated plies.

Figure 9. The feature indicated by the yellow arrow in figure 8.

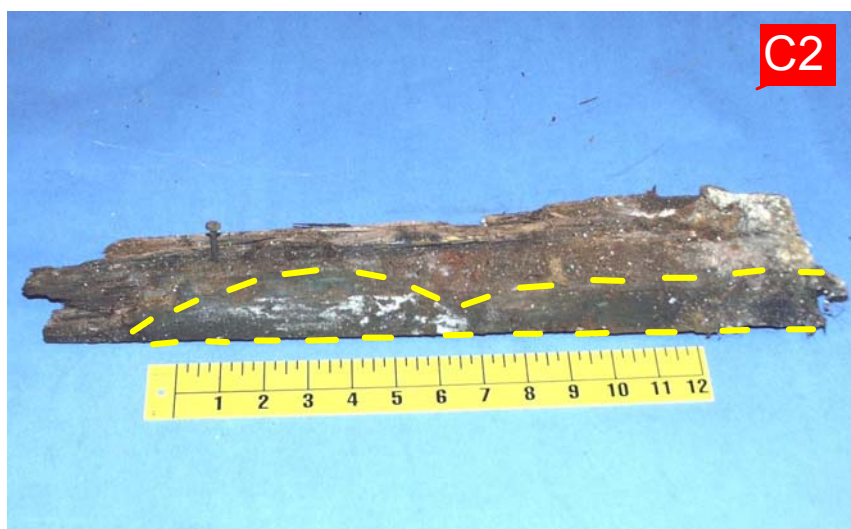
Block piece "C2" was predominantly a piece of wood with soft edges, but one side displayed a hard green material that could not be penetrated by a fingernail. The affected side is illustrated in figure 10 with the green material outlined by the yellow dashed line.

Figure 10. The strut block piece identified as "C2" in figure 1.

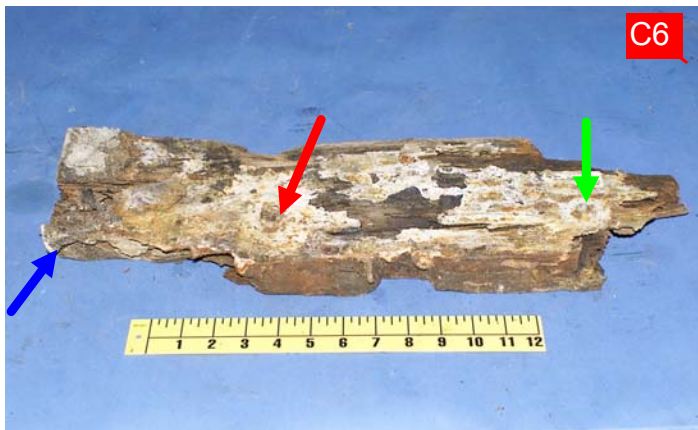
Block piece "C6" appeared to be similar to the other pieces but one side was covered with an off white paint. The painted surface is illustrated in figure 11 with the blue and red arrows indicating other features illustrated in figures 12 and 13. The green arrow indicates an area that felt "rubbery" and when the reverse side was examined it was found that the rubbery area extended to the reverse side, appearing similar to the area within the yellow dashed lines in the right view of figure 13.

Figure 11. The strut block piece identified as "C6" in figure 1.

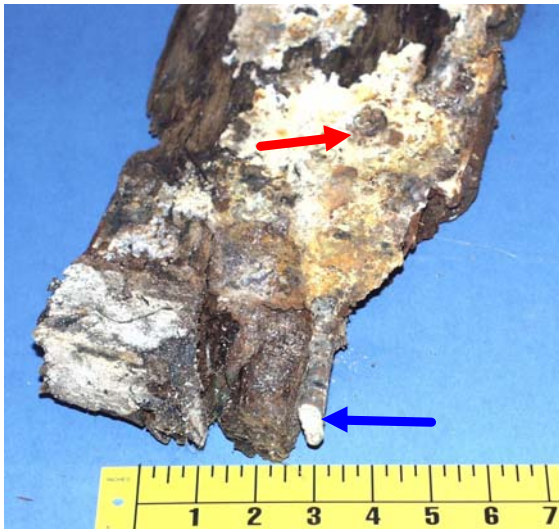
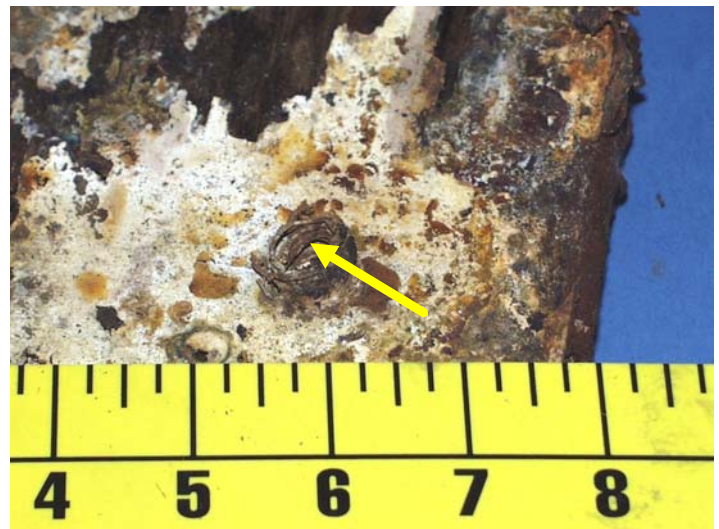
The blue and red arrows in the left view of figure 12 indicate the features similarly indicated in figure 11. The blue arrow indicates the end of a sliver of a white material that appeared to go under the painted surface and towards the feature indicated by the red arrow. The material was approximately  $\frac{1}{4}$ -inch wide, and as can be seen adjacent to the blue arrow in figure 11, it had varying depths. It was easily bent and returned to its original location when released. The feature indicated by the red arrow in the left view of figure 12 is illustrated, at a higher magnification, in the right view. The material indicated by the red arrow was also white and felt similar to the material indicated by the blue arrow in the left view. It appeared to be a tubular protrusion of approximately  $\frac{3}{4}$ -inch outside diameter. The material appeared to have been poured around a bolt, leaving a casting of the bolt threads on the inside diameter of the tubular protrusion. The threads are indicated by the yellow arrow.

Figure 12. A view of the left end (left view) of strut block "C6", as illustrated in figure 11 and a closer view of the feature indicated by the red arrow (right view).

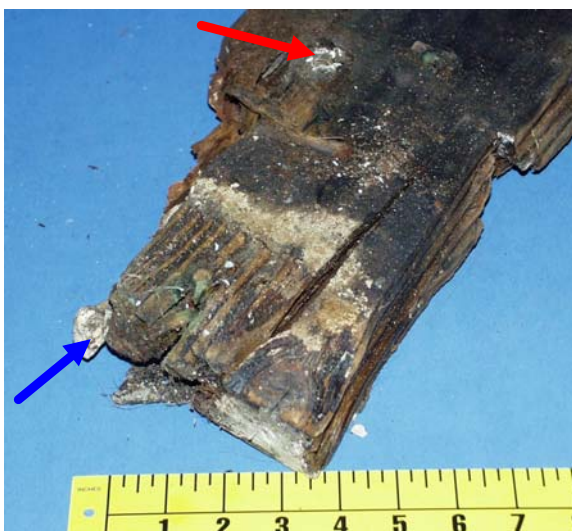
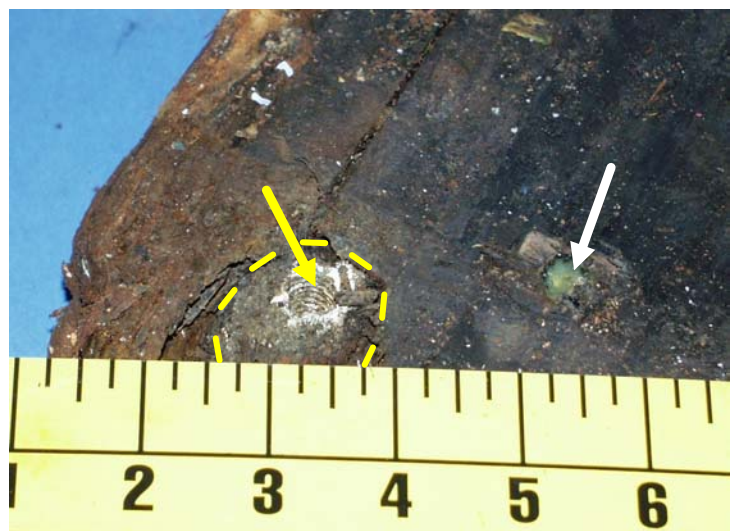
The deterioration of the wood is displayed in the left view of figure 13, which is the opposite surface to that illustrated in the left view of figure 12. The blue arrow indicates the white elastomeric material similarly indicated in the left view of figure 12. The red arrow indicates the other side of the feature similarly indicated in the left view of figure 12 and illustrated in the right view of figure 12. The feature indicated by the red arrow is illustrated, at a higher magnification, in the right view. The yellow arrow indicates the threads, as in the right view of figure 12, and the yellow dashed line indicates the periphery of the material. The white arrow indicates a hole filled with a hard translucent green material similar to that indicated by the white arrow in figure 3.

Figure 13. Underside views of the strut block features illustrated in figure 12.

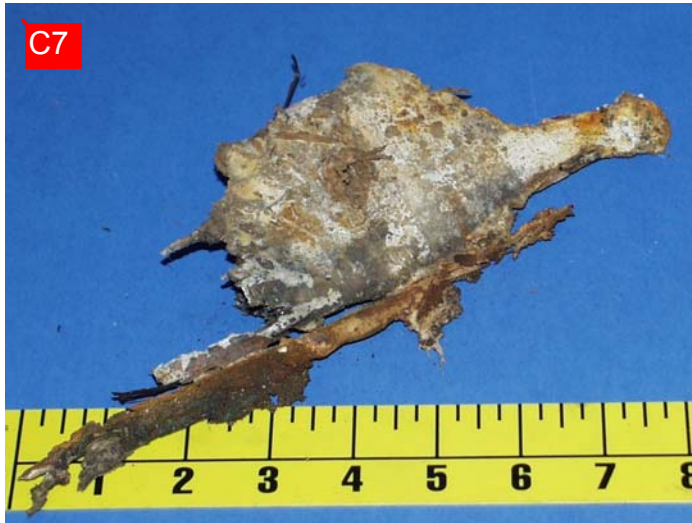
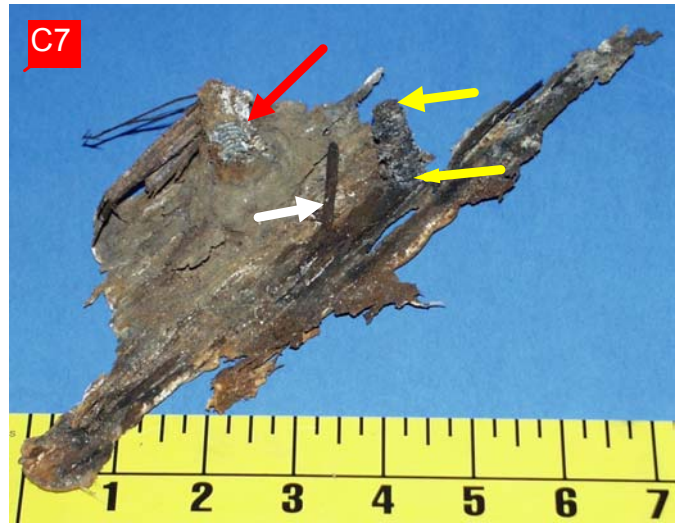
Block piece "C7" consisted almost entirely of a flexible white material similar to the material indicated by the blue arrows in figures 11, 12, and 13 for piece "C6". Some wood fibers were still attached. The left view of figure 14 illustrates the white material and the right view shows the wood fibers and the other features on its reverse side. The red arrow indicates a tubular portion of the white material that had been cast around the threaded portion of a bolt, and the yellow arrows indicate a solid cylinder of white material approximately 1" tall. The white arrow in the right view of figure 14 indicates a sliver of wood.

Figure 14. Both sides of the piece of strut block identified as "C7" in figure 1.

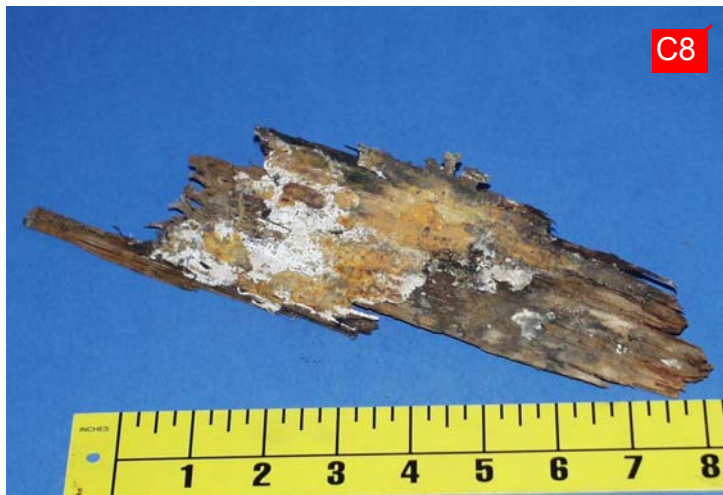
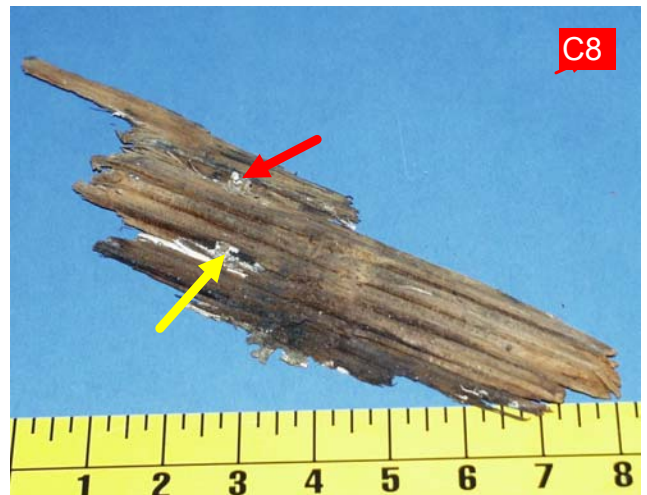
Block piece "C8" consisted of wood with one surface displaying the white paint and a cream colored elastomeric coating as illustrated in the left view of figure 15. The right view illustrates the opposite surface with the red and yellow arrows indicating small cylinders of an elastomeric material similar to that previously described.

Figure 15. Both sides of the piece of strut block identified as "C8" in figure 1.

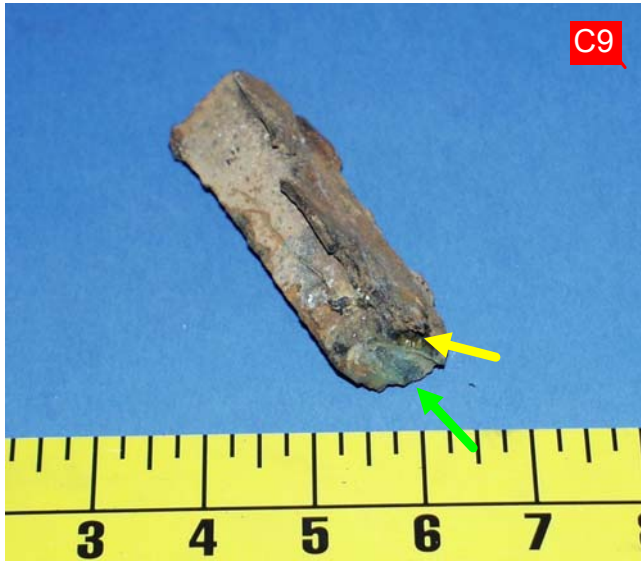
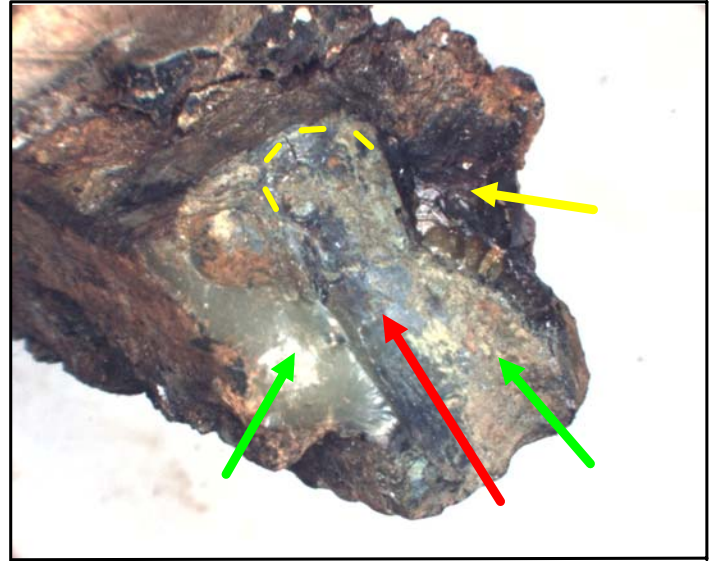
Block piece "C9" appeared to be a rectangular block of a hard translucent green material with wood fibers attached. The left view of figure 16 illustrates the piece with one end displaying the green material also indicated by the green arrow. The yellow arrow indicates a portion of the same end that appeared to consist of a dark brown material. A closer view of the end is illustrated in the right view of figure 16 with the green and brown materials similarly indicated. The yellow dashed line indicates the upper semi-circular edge of the trough indicated by the red arrow. The trough penetrated through the piece suggesting that the green material had been cast around the shank of a bolt.

Figure 16. The piece of strut block identified as "C9" in figure 1 (left view) and a closer view of the end indicated by the green arrow (right view).

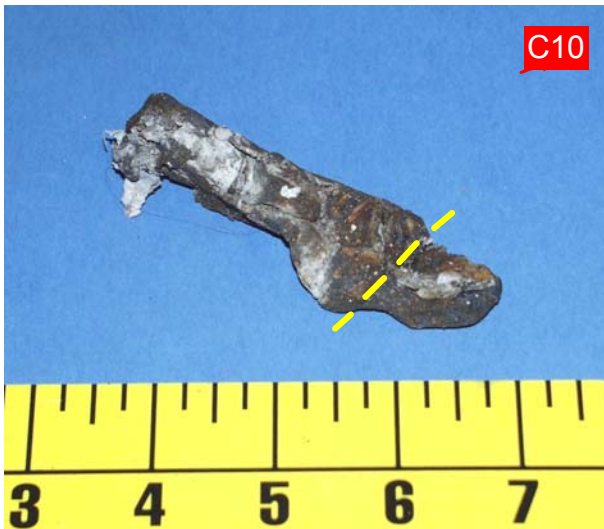
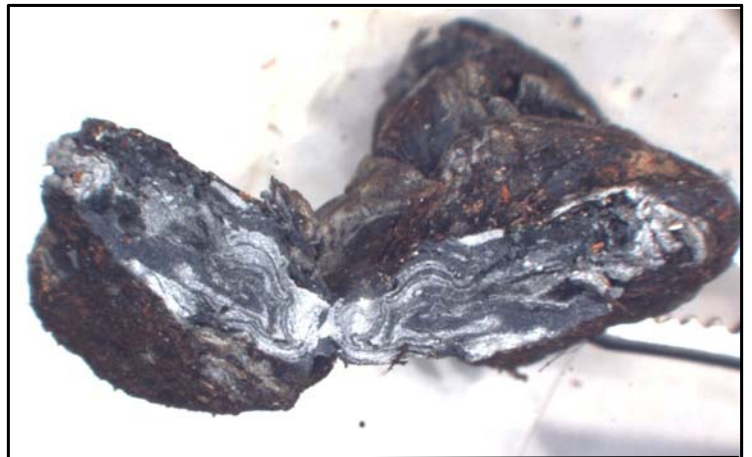
The exterior of block piece "C10" appeared to consist of a gray flaky material that was easily reduced to small particles by a rubbing action. When broken at the yellow dashed line indicated in the left view of figure 17, the interior displayed the swirled dark and light gray layers illustrated in the right view of figure 17.

Figure 17. The piece of strut block identified as "C10" in figure 1 (left view) and a closer view of its internal structure (right view) when broken open at the yellow dashed line in the left view..
